HISTORICAL RECORDS

Maintenance and repair of open-spandrel, reinforced-concrete arch bridges that are prevalent in the USA requires innovative access solutions. **Thomas Topolski** takes us through a tour of three recent projects

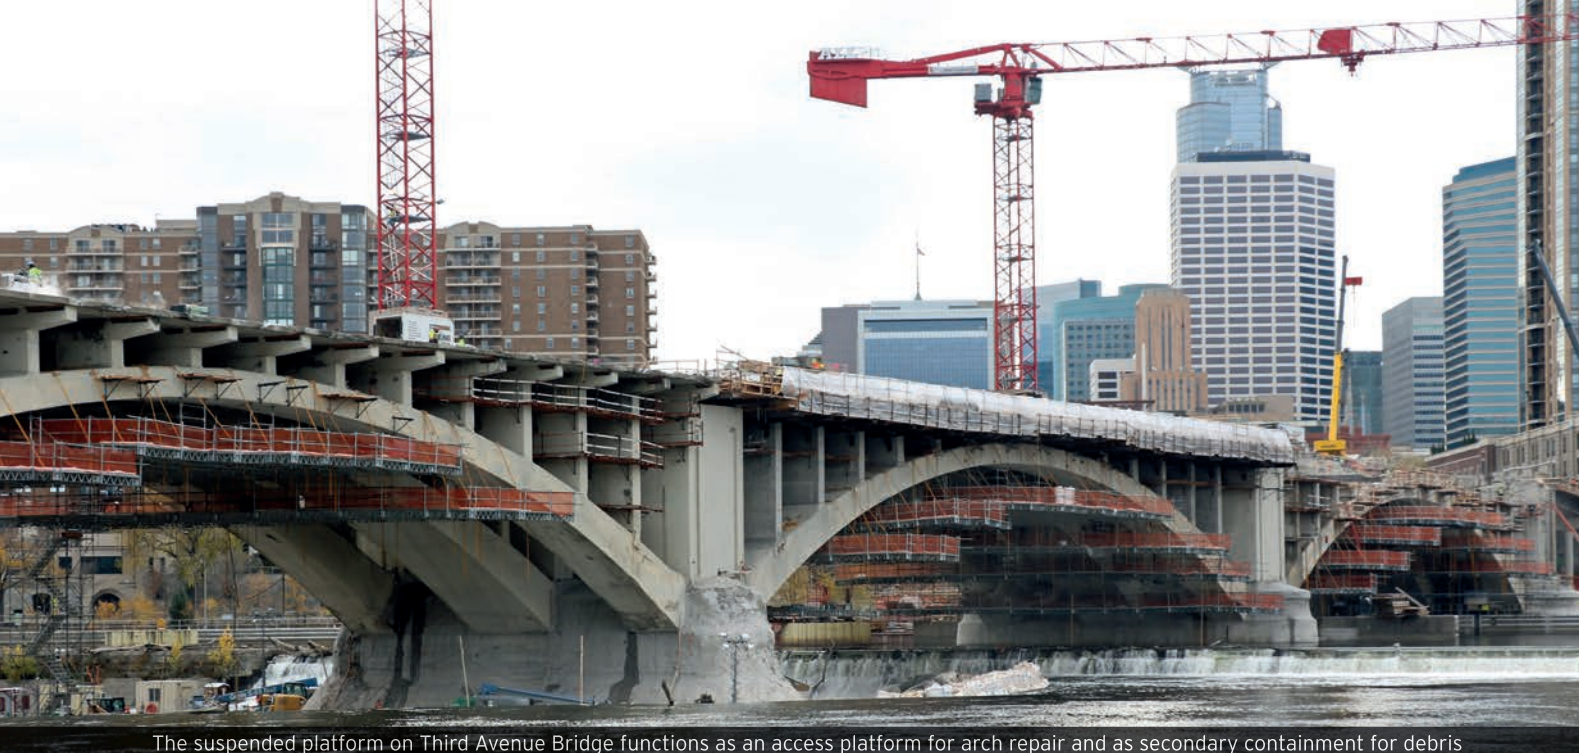
The suspended platform on Third Avenue Bridge functions as an access platform for arch repair and as secondary containment for debris

Because the bridge is relatively low, contractors would normally use barges and erect scaffold on top to access the piers and arches. However, Horseshoe Falls made barge access impossible for spans two to five, and the river is too shallow to support a large barge by spans six and seven. It was therefore decided to use suspended platforms as access, which amounted to approximately 9,291m² and which would also function as a debris shield. And, as the suspended platforms provide a flat surface for working on, they are safer, reducing trip hazards as well as speeding clean-up. In addition to suspended platforms, a flying/cantilevered load concept was also deployed.

The required material loads created a secondary challenge because the contractor wanted a load rating of 2,394Pa in some areas to support debris removal and higher numbers of workers and scaffold stairs. This was addressed by placing suspension chains at closer intervals, which sufficiently increased the load rating, as well as using shorter trusses to create more suspension points. These actions increased the load rating up to a maximum of 3,591Pa where needed.

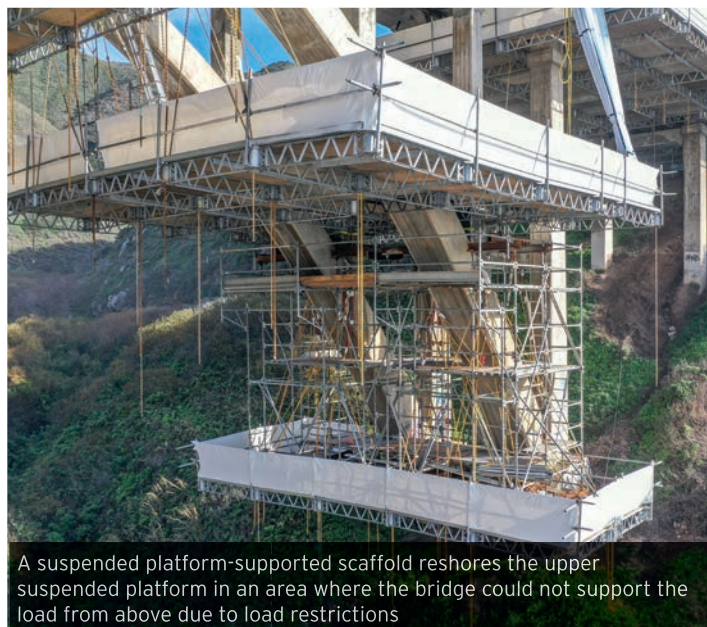
A suspended platform-supported scaffold reshores the upper suspended platform in an area where the bridge could not support the load from above due to load restrictions

The ultimate access solution engineered for Granite Canyon required a unique, multi-tiered configuration of suspended scaffold, supported scaffold, shoring and rolling scaffold – often all combined at once. To help ACC and Caltrans envision an extraordinarily complex access plan on the Granite Canyon Bridge, Brandsafway presented 3D images so they could compare access options and determine the safest, most efficient solution. Brandsafway project manager Greg Mallek said that the use of the technology also improved communication during construction between all parties and trades involved, and was key to completing the project without any incidents and within the allocated budget and timeline.

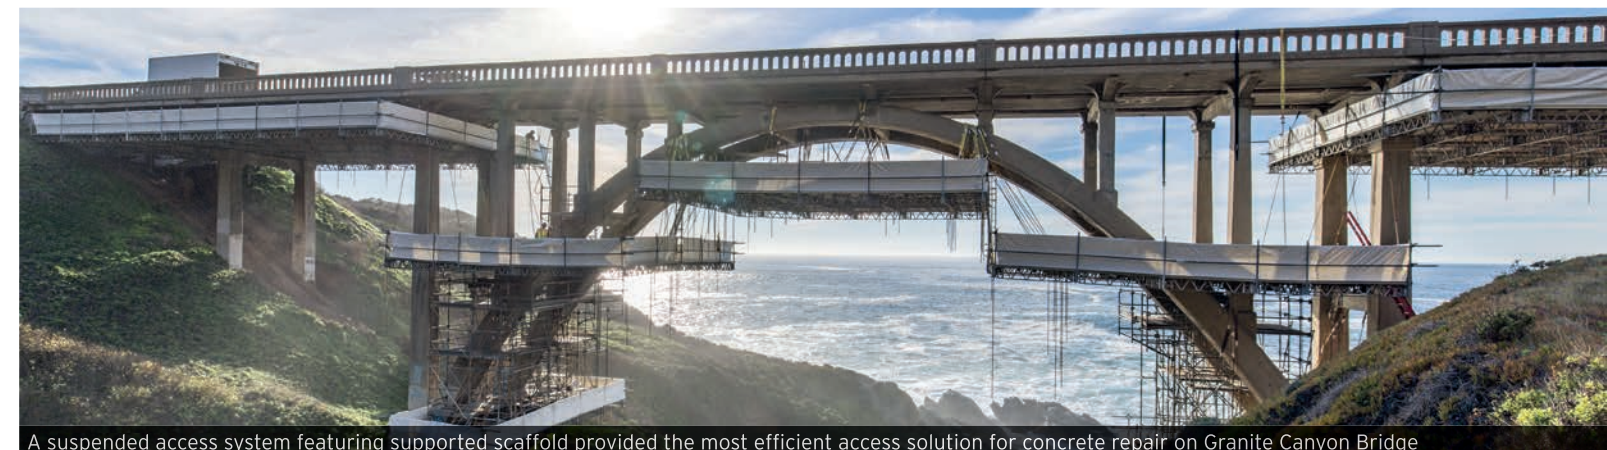
A suspended access system featuring supported scaffold provided the most efficient access solution for concrete repair on Granite Canyon Bridge
